AFRL-PR-WP-TR-2001-2024

**ANALYSIS OF SIMULATED AIRCRAFT
LIGHTNING STRIKES AND THEIR
ELECTROMAGNETIC EFFECTS**

FEBRUARY 2001

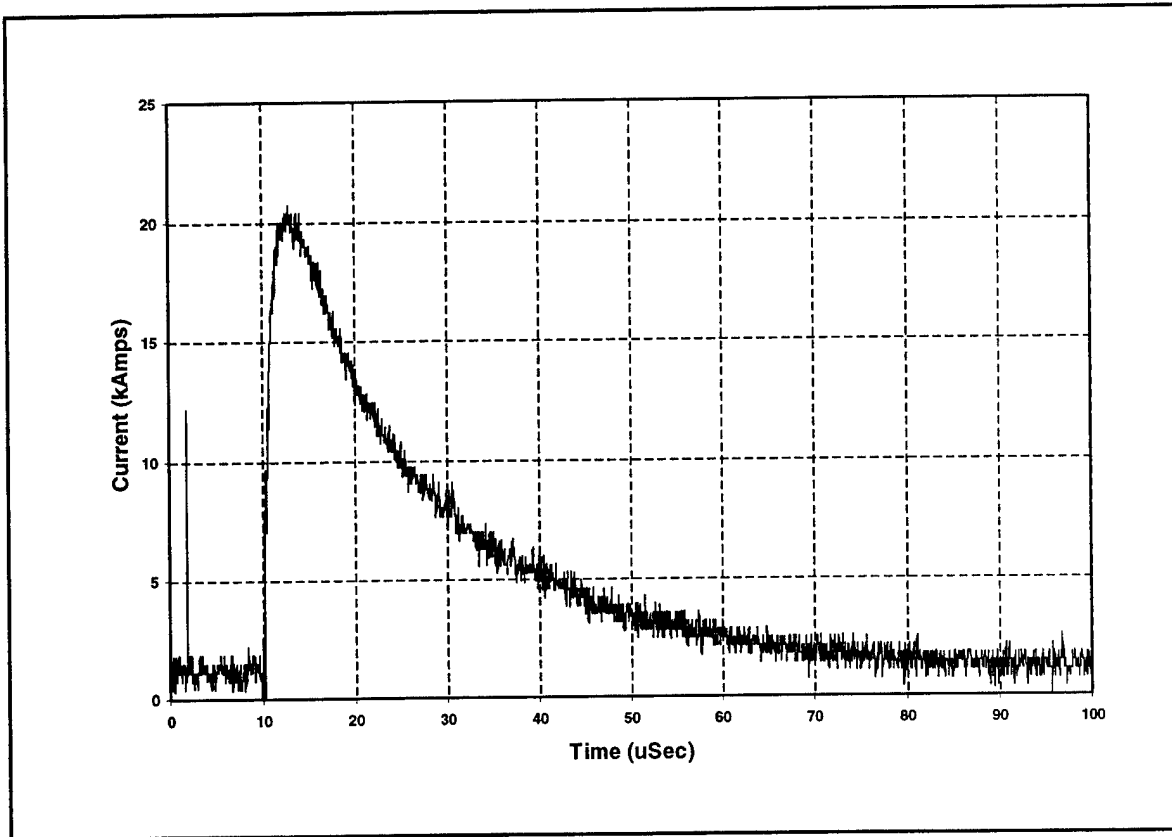
Figure 2. Typical Current Pulse

The output current pulse of the capacitor bank was an overdamped sinusoid. Its characteristic wave shape was determined primarily by the capacitance of the capacitor bank ($C_{\text{tot}} = 4 \mu\text{F}$), the inductance of the capacitor bank ($2 \mu\text{H}$), and the resistance of the damping resistor (5Ω) attached to the capacitor bank's output terminal. Figure 2 shows a typical capacitor bank current pulse used to simulate a low-level lightning strike.

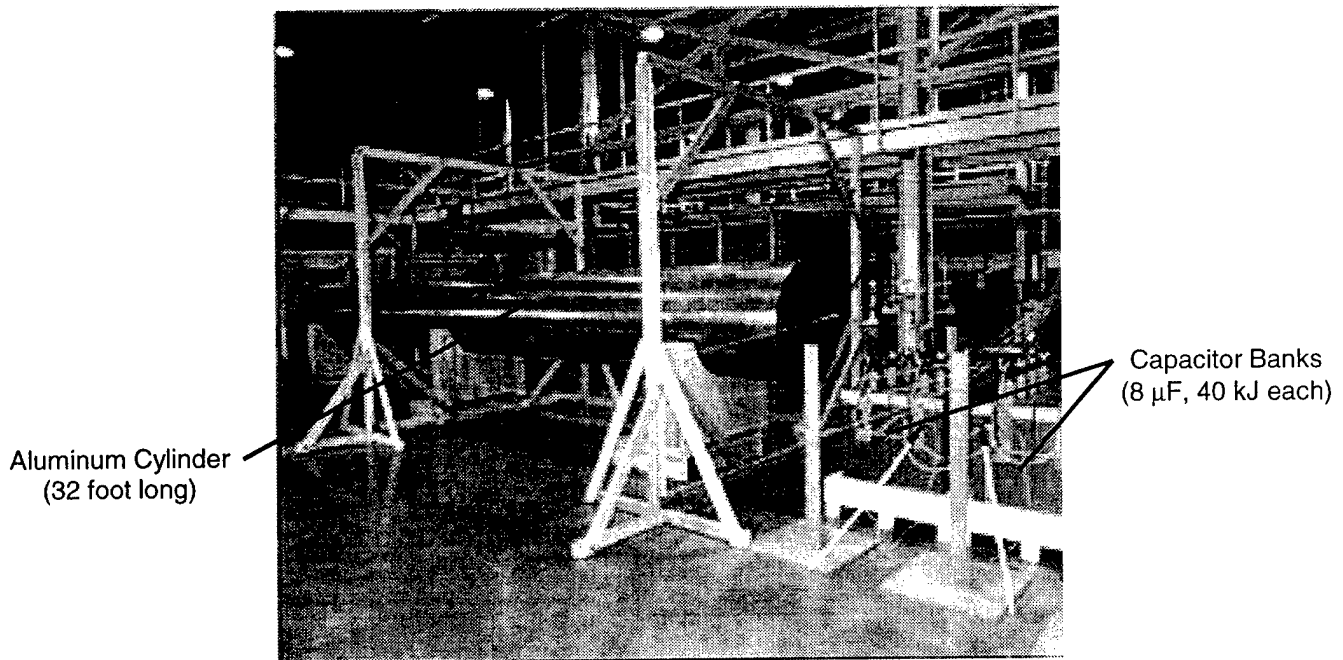
Figure 3. Aluminum Cylinder and Capacitor Bank

A cylinder made from 1/8 inch thick 6061-T4 aluminum is used to simulate the basic geometry of an aircraft fuselage. The cylinder is approximately 38 inches in diameter and consisted of four sections each eight foot in length for a total length of 32 feet. The cylinder is supported from the floor by three wooden stanchions that placed the centerline of the cylinder about five feet above the floor (Figure 3). [2]

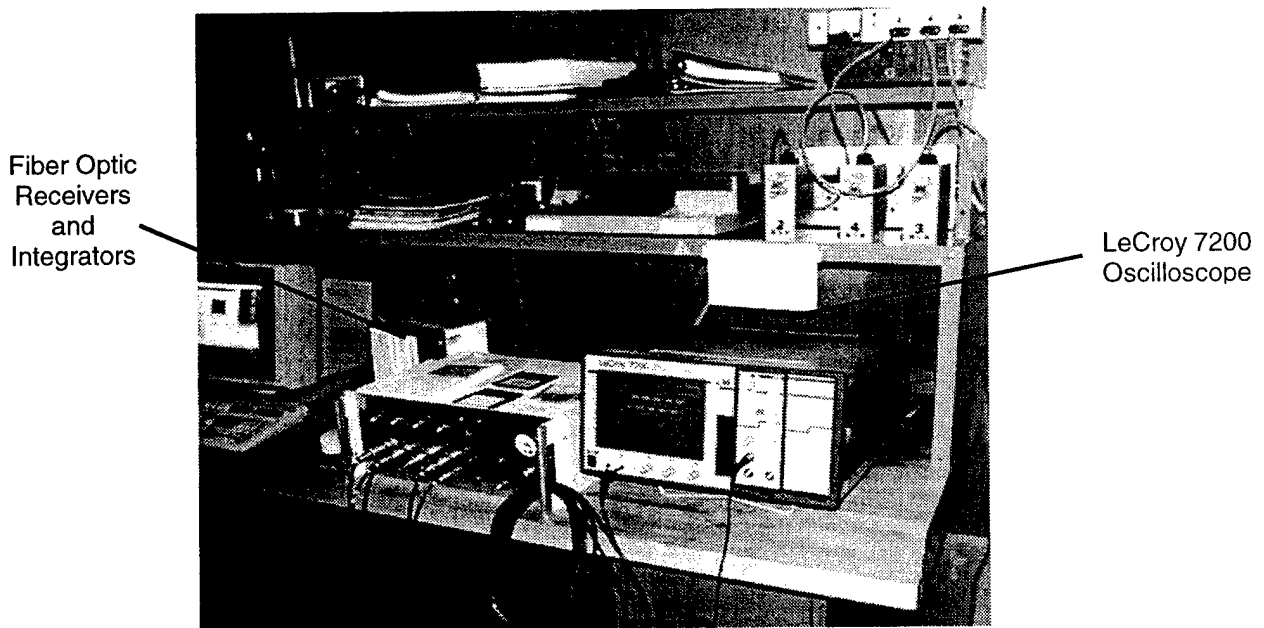
Figure 4. Data Acquisition in Shielded Room

Data was acquired using a fiber optics data link with a response from DC to 150 MHz. The capacitor bank current was monitored through a 10,000:1 current viewing resistor attached to a current transformer made by T & M Research Products, Inc. (Model CT23.9-500-10-100) with a 0.31 - 300 MHz bandwidth. The magnetic fields were monitored using loop sensors while surface currents were tracked with a surface mounted B-dot ground plane sensor manufactured by EG&G (Model MCL-S7A(R)).

The sensor signals were transmitted through fiber optic cables (SIV/30) using a Meret Inc. battery operated transmitter module to a shielded room where they were received and either integrated (B-dot signals) or sent directly to a LeCroy 7200 Precision Digital Oscilloscope for analysis and storage (Figure 4).

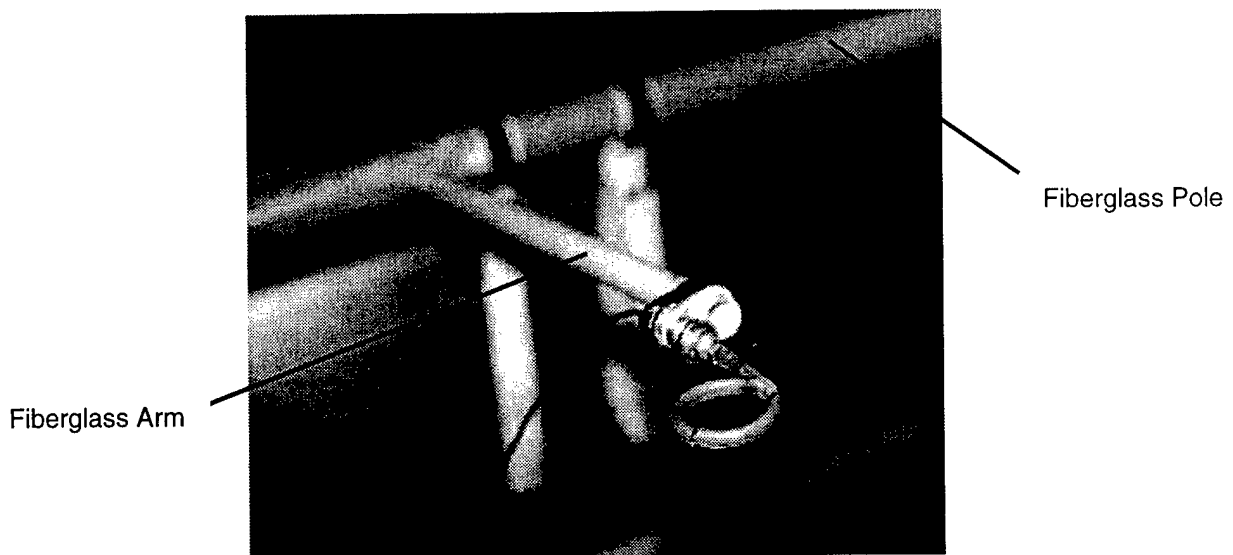
Figure 5. Magnetic Field Loop Sensor

The primary reason for conducting these simulated lightning strike tests was to track and record the resulting magnetic fields at different locations inside the aluminum cylinder as the current pulse from the capacitor bank traveled down the length of the simulated aircraft fuselage. Since the magnetic fields of primary concern were internal to the “closed” cylinder, a scheme was devised to locate a magnetic field loop sensor at various positions within the cylinder.

The scheme consisted of a long fiberglass pole running through the center axis of the cylinder with internal bearing supports appropriately spaced along the pole’s length. Perpendicular to the pole was a smaller fiberglass arm that was used to mount the magnetic field loop sensor (Figure 5). Since the centrally located pole protruded through the ends of the cylinder, it could be rotated to obtain various angular positions for the sensor. It could also be moved along the axis of the cylinder to obtain various axial sensor positions. The location of the sensor on the smaller arm provided a range of radial positions as well. This sensor-positioning scheme enabled magnetic field “mapping” inside the cylinder where panels had been removed or reconfigured. It also saved a considerable amount of time when repositioning the sensor since the panels, which each had 38 screws fastening them to the cylinder, did not have to be unscrewed and then re-screwed into the cylinder each time the sensor needed to be repositioned.

To better understand the analysis, it should be noted that the magnetic field loop sensor's active plane is parallel to the cylinder's radius (Figure 5). Therefore, magnetic flux *parallel* to this plane does not generate a signal. The sensor's "directionally dependent" signal only measures flux with a vector component orthogonal to its "active" plane. The fact that the sensor's signal may go to "zero" or change polarity implies nothing about the resultant magnitude of the total magnetic field, just the component that is normal to its "active" plane. [3]

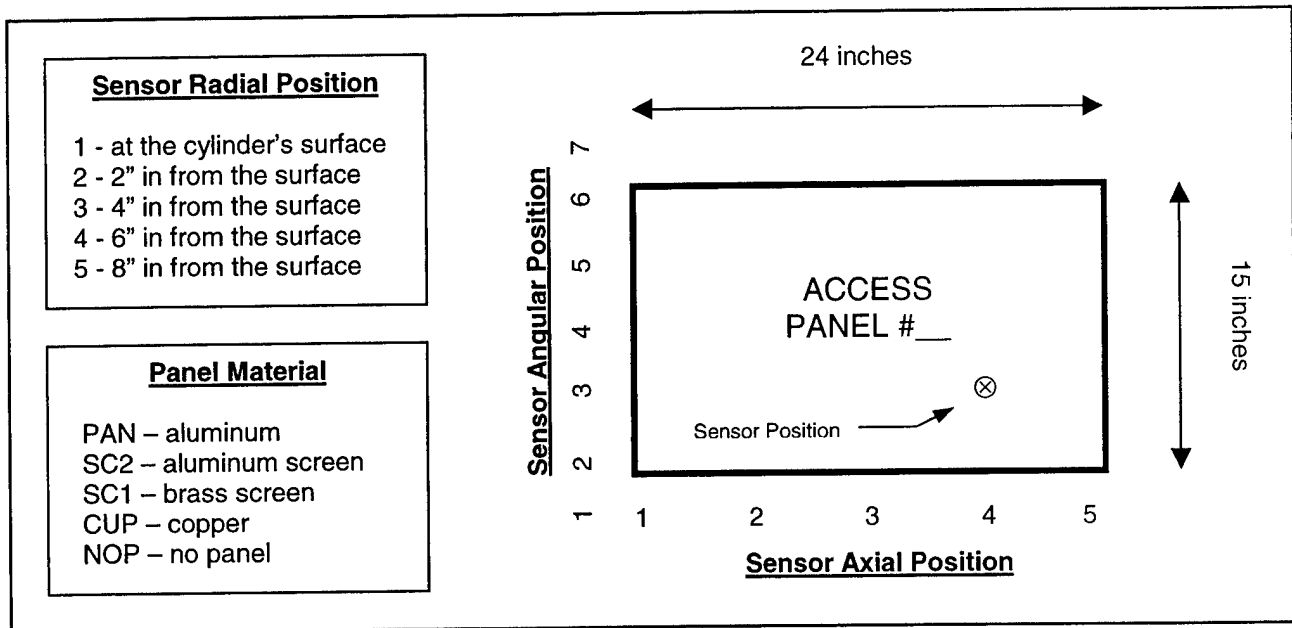
Figure 6. Sensor Location and Panel Material Identification

To track sensor position during a test, a grid system was established for the cylinder's removable access panels that identified the position of the sensor during data acquisition (Figure 6). Each of the access panels was numbered 1 through 16 starting at the cylinder's end closest to the capacitor bank. We also investigated four types of panel materials in one area of the cylinder. The "materials" included aluminum, copper, brass screen and air (no panel).

To assist in managing data files, each test run was assigned a file name with the following format: X_##_YYY.###. The "X" represented the type of sensor being used, i.e. S = H-Field loop sensor, I = current sensor, etc. "##" identified the cylinder's panel number where the test occurred. "YYY" represented the panel's material (Figure 6). "###" identified the axial, angular, and radial positions respectively of the loop sensor. As an example, file S_03_PAN.433 contained the signal from the loop sensor (S) located 4" below the surface of Panel #03 (material: aluminum). The sensor's axial and angular position are located in Figure 6 with the "⊗" symbol.

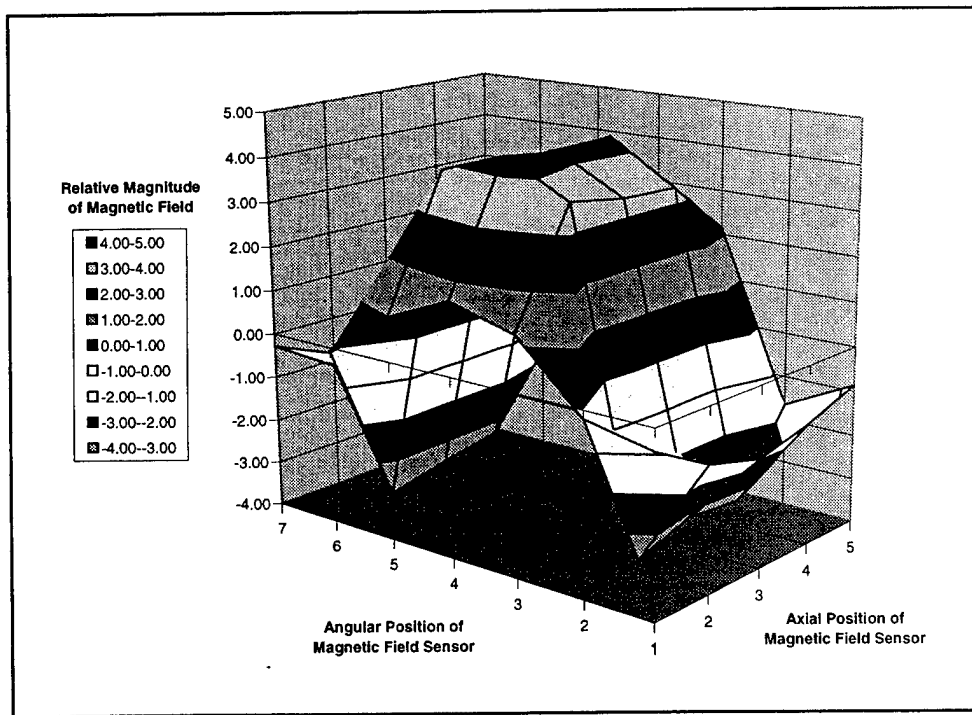
Figure 8. Relative Magnitude of Magnetic Field Across Panel #03 without the Panel in Place (Open)

Figure 8 shows a 3-D contour map of the magnetic field's magnitude and polarity fluctuations as the sensor was moved to the various 35 grid locations.

The following insights are gained from reviewing Figure 8 and Figure 9. A maximum “negative” magnetic field is found along the top and bottom edge of the opening. As the magnetic field loop sensor is rotated toward the center of the opening, the polarity of the field reverses and a maximum “positive” magnetic field occurs. Keep in mind that the magnetic field loop sensor remained at a constant radial distance from the main axis of the cylinder as it was rotated to all 35 positions to obtain the 3-D contour mapping. The sensor’s radial position was adjacent to the "skin" of the simulated aircraft fuselage.

When comparing the magnetic field profile across Panel #03 with Panel #14 (Figure 8 compared with Figure 10), it can be seen that each 3-D contour map has a similar characteristic profile. Maximum negative values occur along the bottom and top edge of the opening and the maximum positive values are centered in the opening. Due to cancellation effects of equal and opposite field contributions from the top and bottom edges of the panel's opening, one might initially anticipate little or no magnetic field to be present in the center of the panel's opening. Further analysis shows this is not true.

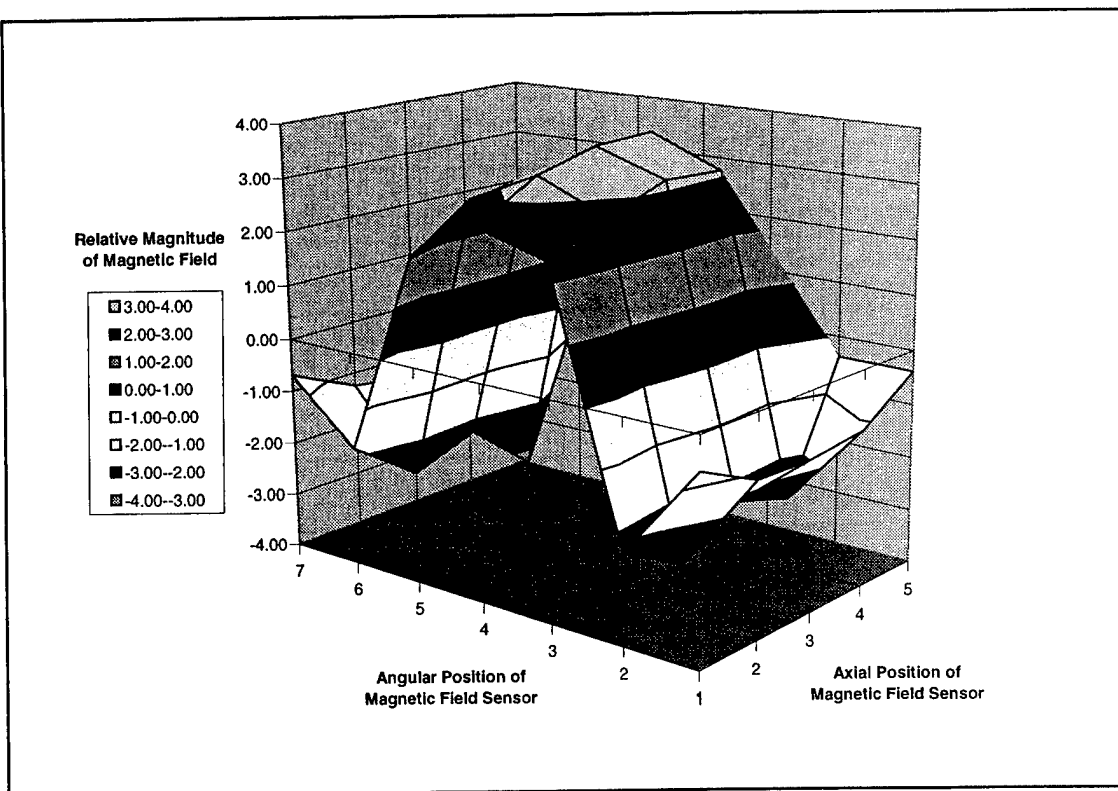
Figure 10. Relative Magnitude of Magnetic Field Across Panel #14
without the Panel in Place (Open)

A similar magnetic field contour mapping was done on the cylinder’s end opposite the capacitor bank (Panel #14). This area was nominally five feet away from the end of the cylinder where the coaxial return path wires were connected. Figure 10 shows the magnetic field contour map for the area of Panel #14 with the panel removed and a capacitor bank current of 3.3 kA.

Although Panel #14’s 3-D plot is characteristically similar to Panel #03’s plot, the overall magnitude has been reduced, i.e. the peak positive and peak negative magnetic field values are less. It is believed that as the current pulse travels the additional 22 feet from Panel #03 to Panel #14, diffusion effects have rearranged the surface current density in the aluminum cylinder to a more uniform distribution. The result is a lower amplitude waveshape.

It should also be noted that the 3-D profiles along the center, left edge of the panel openings (Positions 131 - 151) differ considerably. Panel #14’s relative magnetic field value is approximately 70% higher than Panel #03’s value. This may be attributed to Panel #14 having a more uniform current distribution around the panel’s left edge due to its location 22 feet further down the aluminum cylinder from Panel #03’s left edge. Bear in mind that four conductors connect the capacitor bank to the aluminum cylinder and Panel #03 was located between two of the current injection points. Also, the left edge of Panel #03 was only five feet from the capacitor bank connection while the left edge of Panel #14 was 26 feet away from the connection point.

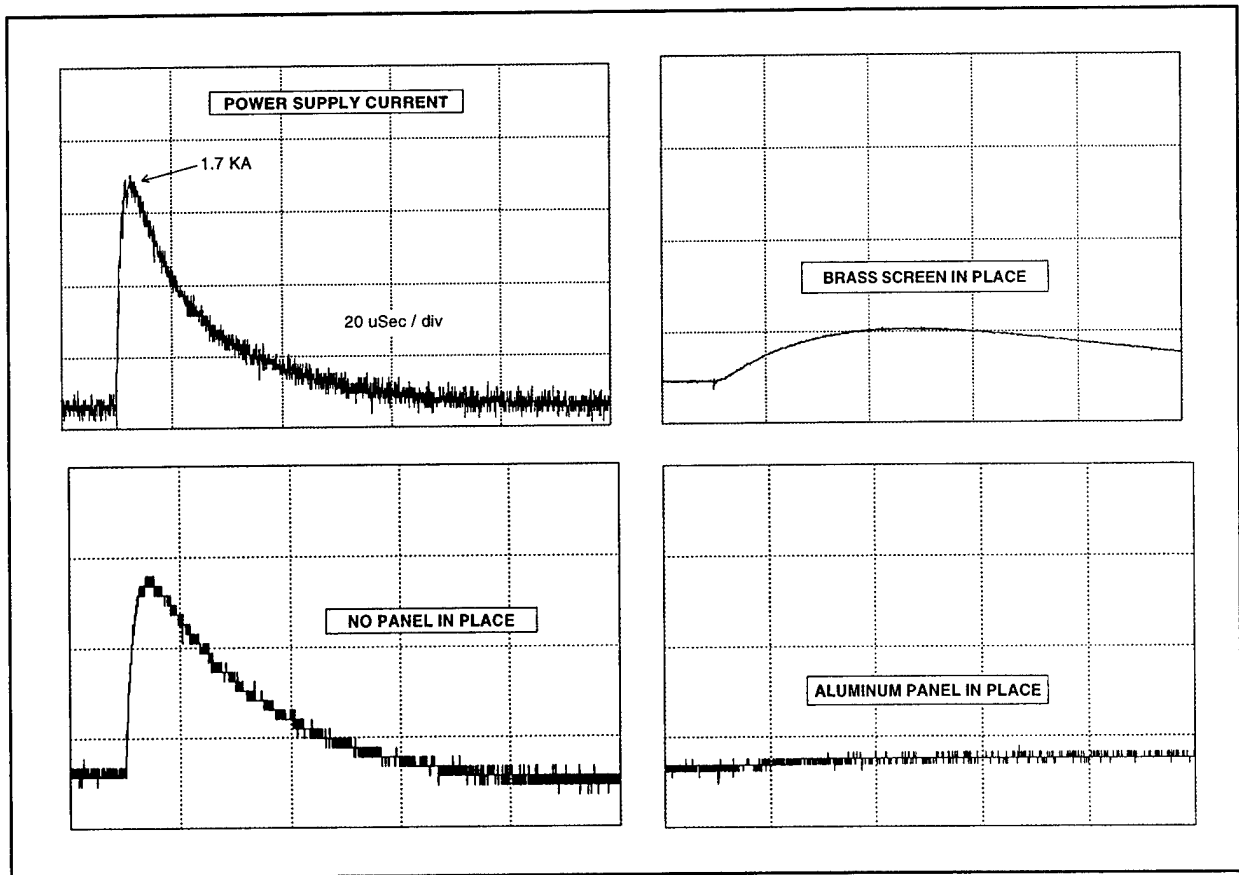
Figure 11. Relative Magnetic Field Variations at Panel #03 (Position 351)
Due to Various Panel Materials

Figure 11 shows the relative magnetic field variations that result from changing the panel's material. The aluminum cylinder was subjected to current pulses of approximately 1.7 kA while three different panel configurations were investigated – air, brass screen and aluminum. For each shot, the magnetic field loop sensor remained in sensor position 351, i.e. centered in the middle of Panel #03 and even with the cylinder's skin surface.

As expected, with Panel #03 absent, there is a large aperture for the magnetic field to penetrate the aluminum cylinder and be detected by the magnetic field loop sensor. The magnetic field's characteristic curve tracks with the rise and fall of the capacitor bank's current pulse. When the opening is covered with a brass mesh screen (wire diameter $\approx 160\ \mu\text{m}$ with a $200\ \mu\text{m} \times 200\ \mu\text{m}$ square opening), the magnetic field amplitude is reduced by a factor of approximately 3.6. The peak magnetic field is delayed by about $40\ \mu\text{sec}$ due to an impedance change ($L_{\text{panel}} = 0.646\ \mu\text{H}$, $R_{\text{panel}} = 0.030\ \Omega$) and the low pass filtering effect of the wire mesh. Finally, when the aluminum panel is screwed into place ($L_{\text{panel}} = 0.611\ \mu\text{H}$, $R_{\text{panel}} = 0.021\ \Omega$) the aperture is "sealed" magnetically, enhancing the shielding capacity of the cylinder to the extent that the magnetic field loop sensor is primarily sensing "noise" biased by a very weak magnetic field signal. [4]

To determine the shielding effects when the aluminum panel was screwed into place, a similar set of test shots was conducted with the sensor positioned at the various matrix positions of Panel #03 once the aluminum panel was screwed in place (38 screws per panel). The aluminum panel shielded the magnetic field sensor so well that the sensor only detected a very small signal that was dominated primarily by noise. A similar result occurred when a copper panel was secured in place. (A sample plot with the aluminum panel in place can be found in the bottom right insert of Figure 11 on page 15.)

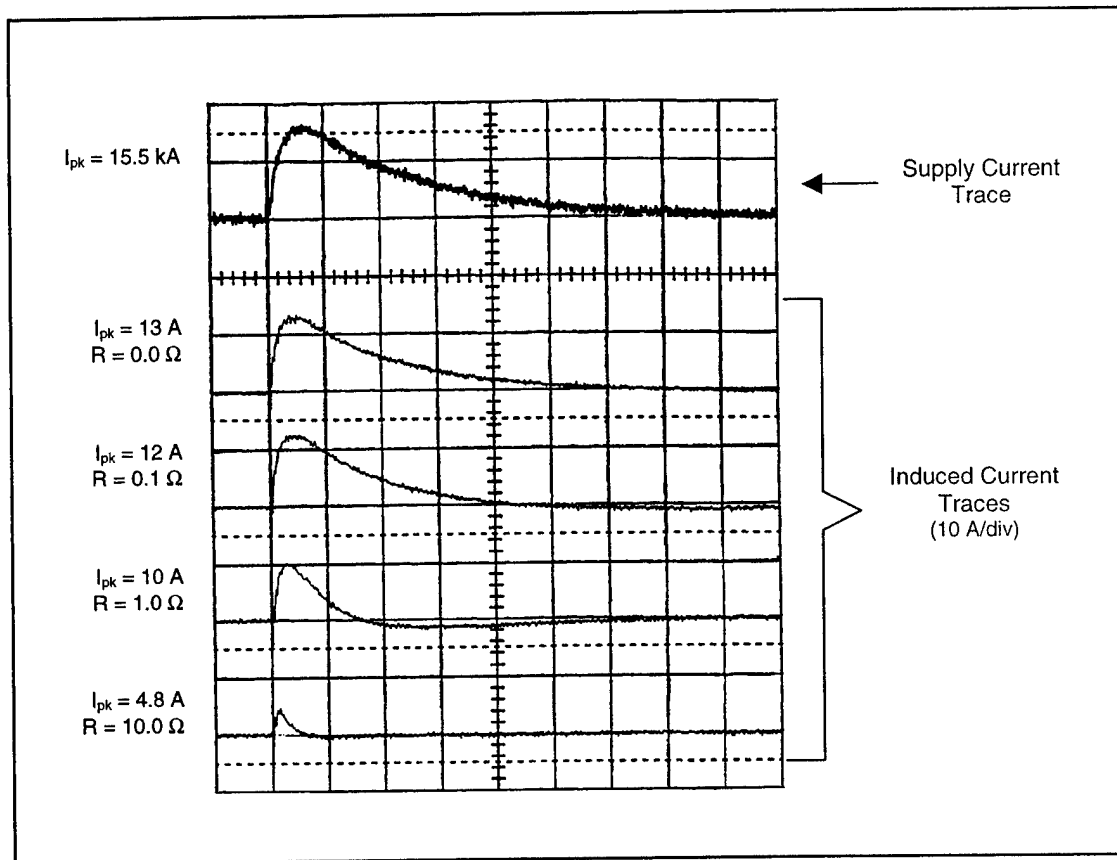
Figure 12. Induced Wire Currents with Various Resistors Connected in Series

Next, various resistors were added in series with the 24 foot long wire to see the effects on the induced current. Figure 12 shows a supply current of 15.5 kA and the resulting induced current traces when four different resistors were connected in series with the wire. Both Panel #03 and Panel #12 were open to generate the induced current traces.

Not only does the peak induced current value decrease as resistance increases but the induced current traces also dip below zero as the transmission line time constant changes with the various resistance values. This is to be expected as the system becomes less damped.

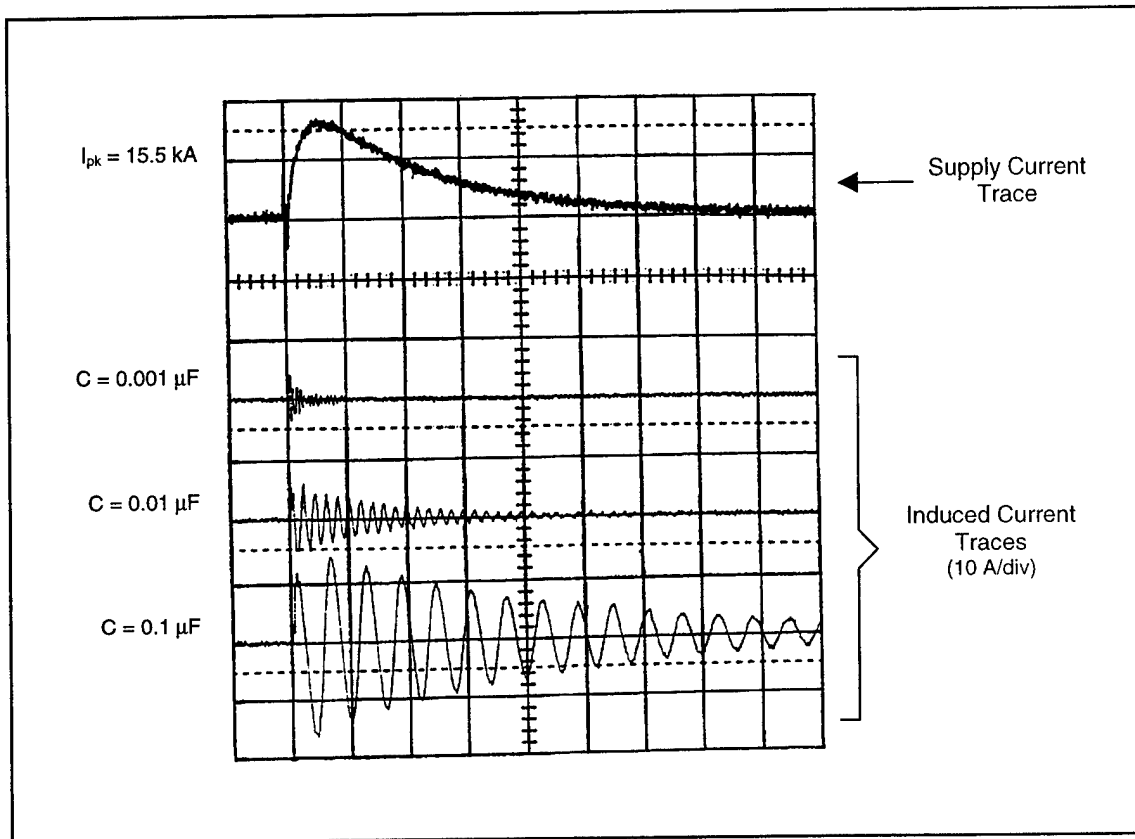
Figure 13. Induced Wire Currents with Various Capacitors Connected in Series

Finally, various capacitors were added in series with the 24 foot long wire to see the effects on the induced current. Figure 13 shows a supply current of 15.3 kA and the resulting induced current traces when three different capacitors are connected in series with the wire. Again, both Panel #03 and Panel #12 were open to generate the induced current traces.

When the capacitive components are added to the circuit, the energy rings between the inductance stored in the circuit's loop ($\approx 12 \text{ ft}^2$) and the added capacitance. As the capacitance increases, the amplitude of the oscillations increase and the frequency decreases due to impedance and time constant changes.
